The Joy of Geodetics

Topics Covered in this Presentation

USPS Cooperative Charting / Geodetic Program

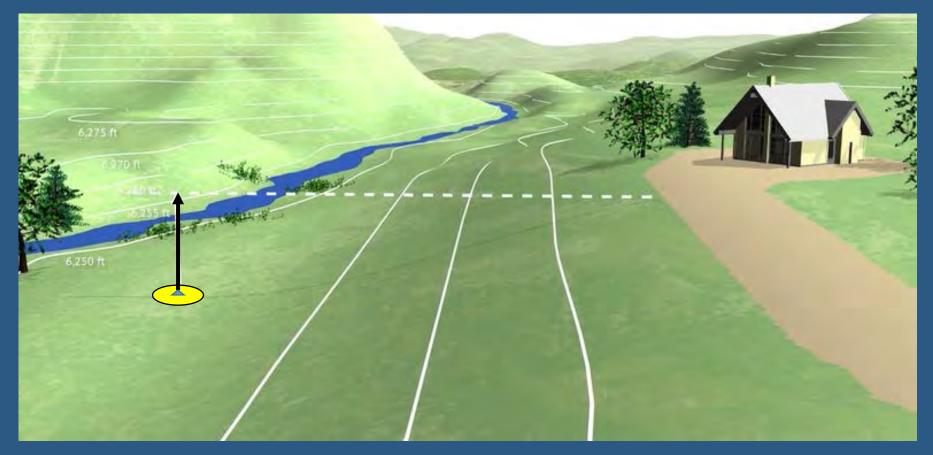
Vertical Control Marks

- Used for elevations, water depths, flood plains
- Current NA Vertical Datum is NAVD 88 (1988)
- The "0" elevation reference point is the mean tide at Father Point tidal station, Rimouski, Quebec CAN

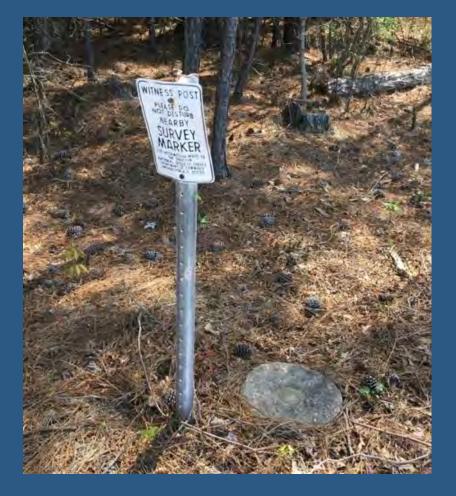
"Witness Posts"

- Signs usually placed close to a mark (often 1-2 ft)
- Lets public know a survey marker is nearby
- Datasheets often give distance and direction from mark

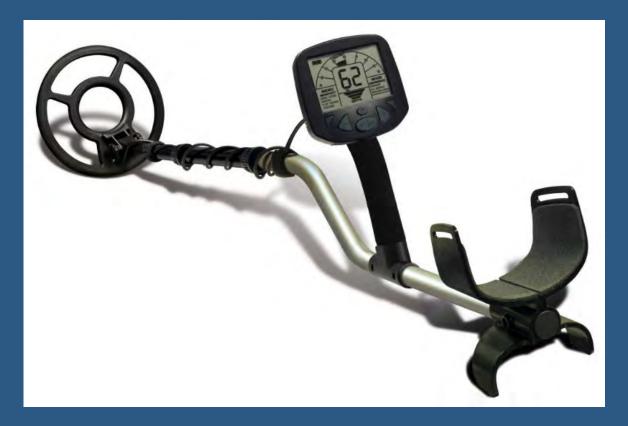
Metal Detector

- They can be located with the aid of a metal prod or metal detector – and a small spade for shovel digging down to it
- Sometimes there is a small depression that can be seen or felt by foot - the marker is often under that depression

Useful tool if mark is not visible in ground

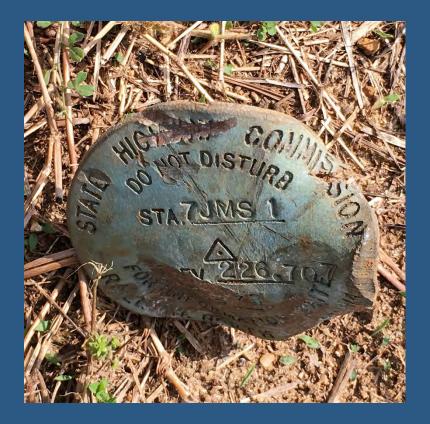
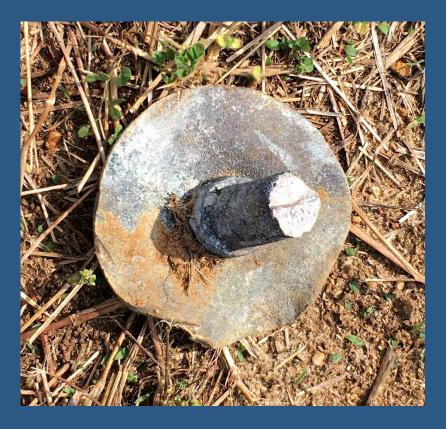
AH4783 – Benson, NC

Mark that is broken from metal shaft and concrete encasement

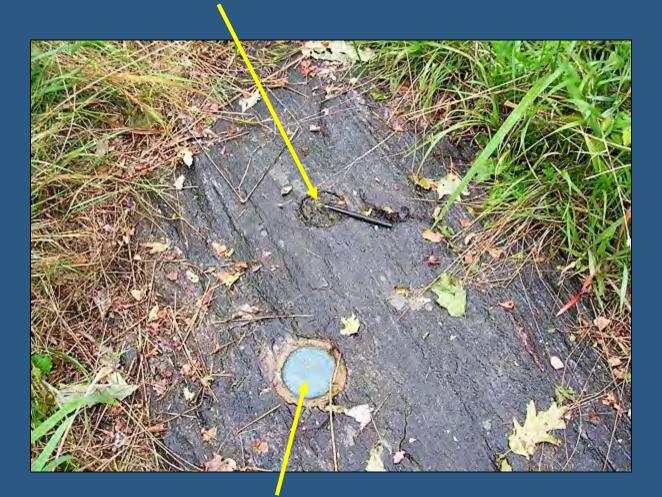
Original mark set in 1833 by Ferdinand Hassler a drill hole 2.5" in diameter and 10" deep

Bronze disc mark later set by National Geodetic Survey in 1932

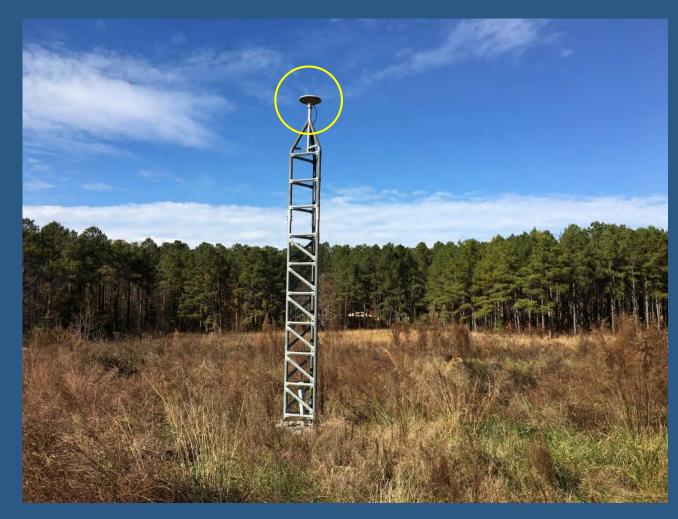
Mark Modernization: GPS "Continuously Operating Reference Stations" (CORS) also part of the National Spatial Reference System

Approx. 2000 CORS Stations established in 2015 and growing
